Innovative Housing Grants Program

ALBERTA BUILDING ENVELOPE FAILURE ANALYSIS

June 1991

G. F. Johnson
Morrison Hershfield Limited

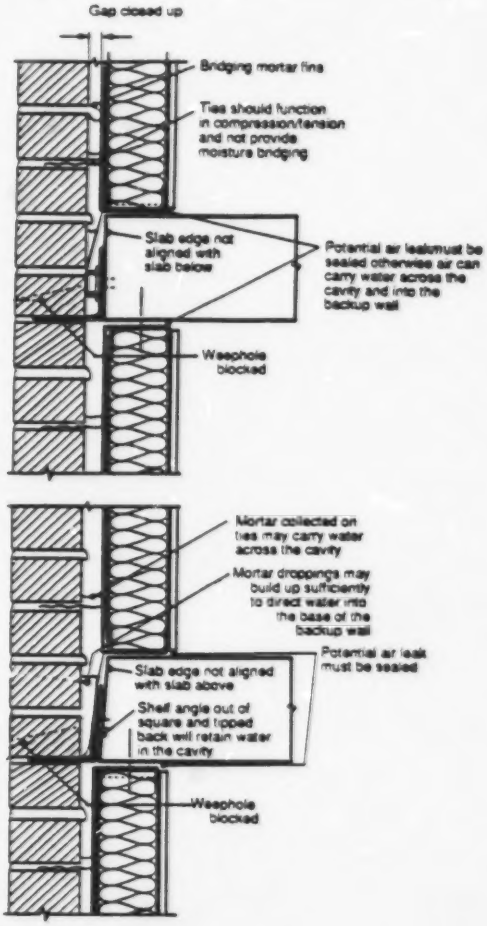
Water Transport Mechanisms

Gap closed up
Bridging mortar fins
Ties should function in compression/tension and not provide moisture bridging
Slab edge not aligned with slab below
Potential air leakmust be sealed otherwise air can carry water across the cavity and into the backup wall
Weephole blocked
Mortar collected on ties may carry water across the cavity
Mortar droppings may build up sufficiently to direct water into the base of the backup wall
Potential air leak must be sealed
Slab edge not aligned with slab above
Shelf angle out of square and tipped back will retain water in the cavity
Weephole blocked

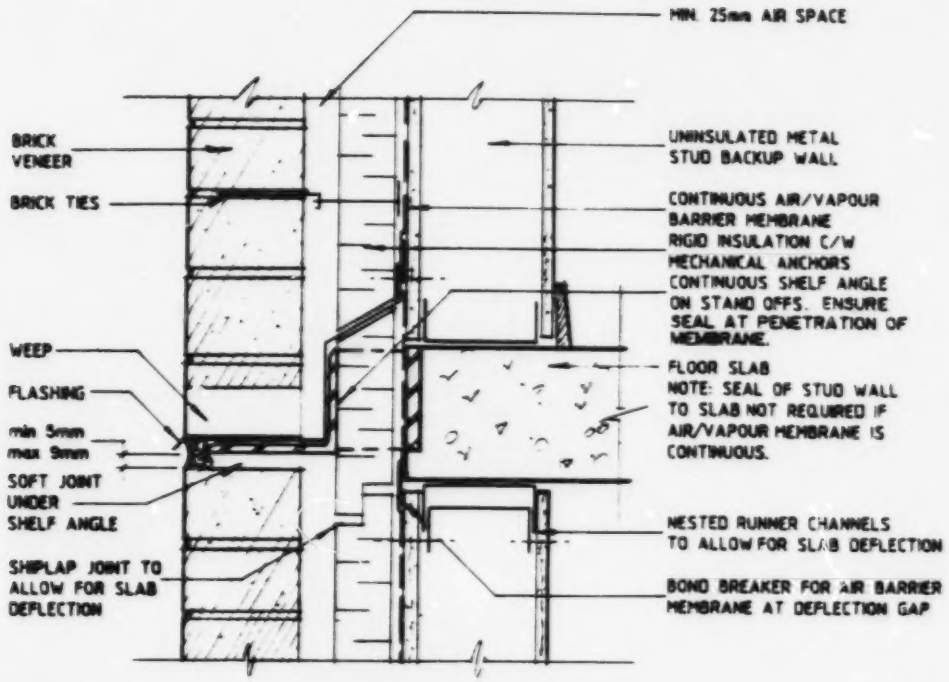
Brick Veneer Photograph
Figure 8

Mortar droppings behind veneer, flashing stops short of exterior face of veneer, no soft joint under veneer at support

procedure necessitated the removal of three or four courses of brick above the shelf angle in addition to the provision of a soft joint under the angle (see Figure 8, page 39). The cost for this repair work is close to $1700.00 per suite. The last example, building 38, has a concrete block veneer supported not on a shelf angle, but on an extension of the floor slab. Deflection of the floor slab has transferred considerable load onto the veneer and the veneer has failed in many locations. Proper repair of this condition requires the complete removal and replacement of most, if not all, of the block work. The cost for this work would probably exceed $4,000.00 per suite. The slab extension is a very significant thermal bridge and source of water infiltration. It constitutes a problem in its own right (see Figure 7, page 38). The best solution in this case would be to redesign the entire cladding system so the end of the slab is inside the envelope.

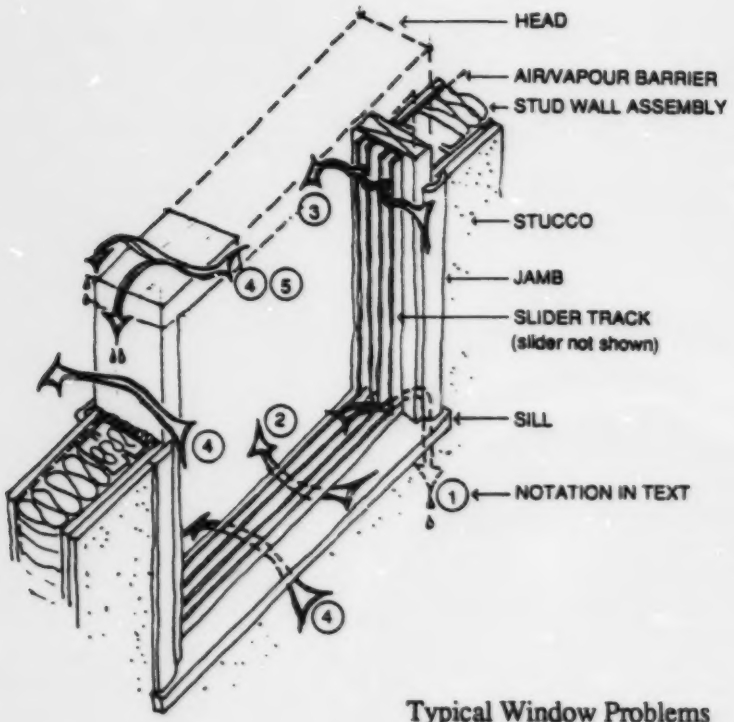
Typical Window Problems
Figure 11

Typical types of window problems identified in our survey are shown schematically in Figure 11. Because it has the worst record of performance, a horizontal slider in a single wythe stud wall is depicted. Other window and wall assembly combinations suffer similar problems but usually not to the same degree.

Location 1 illustrates water infiltration at the sill/jamb connection, by far the most serious and common. The tracks become filled with water due to plugged or nonexistent drain holes and the poor seal at the junction of the sill and jamb allows the water to enter the assembly. This problem is usually due to a combination of low quality windows and poor maintenance.

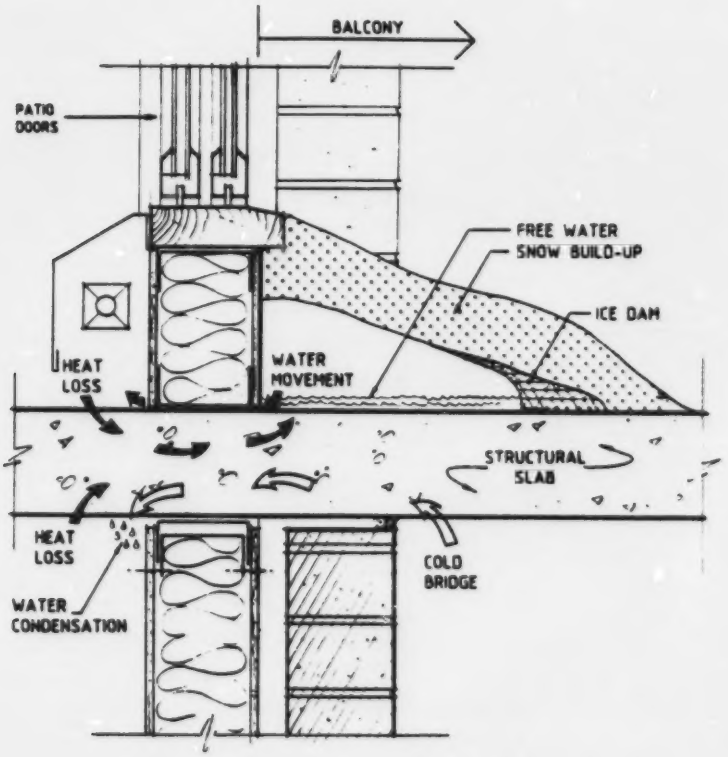
Balcony slab detail at Penetration of Envelope
Figure 12

Complaints of water infiltration at the base of the wall adjoining the balcony were more numerous than complaints about patio doors (see Figure 12).

Although there are only four instances where this problem is listed as serious in our survey table, there are many more that could be classed as inconveniences. This is an ongoing problem in building 28; thus when the developer decided to construct another identical building (#29), it was constructed with the balconies completely independent of the main structure. The second building has not experienced similar problems.
